STM8S007xx and STM8S20xxx device limitations

This errata sheet applies to revisions X, Y/6, V and W/7 of the STMicroelectronics STM8S007xx and STM8S20xxx products.

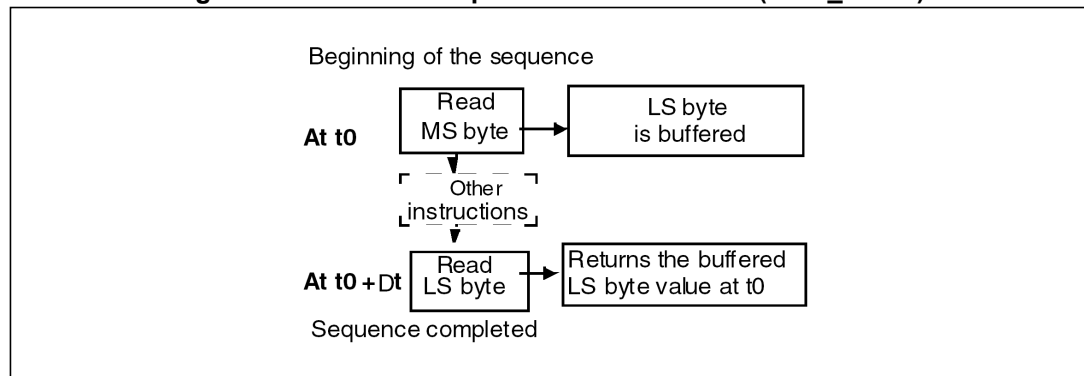
Figure 1. 16-bit read sequence for the counter (TIMx_CNTR)

An 8-bit buffer is implemented for reading the 16-bit counter registers. Software must read the MS byte first, after which the LS byte value is buffered automatically (see *Figure 1*). This buffered value remains unchanged until the 16-bit read sequence is completed.

When any multi-cycle instruction precedes the read of the LSB, the content of the buffer is lost and the second read returns the immediate content of the counter directly.

Do not use multi-cycle instructions before reading the LSB.
