**66AK2H06/12/14**  
**Multicore DSP+ARM KeyStone II SOC**  
**Silicon Revisions 1.0, 1.1, 2.0, 3.0, 3.1**

# Silicon Errata

Literature Number: SPRZ402E  
June 2013–Revised June 2017

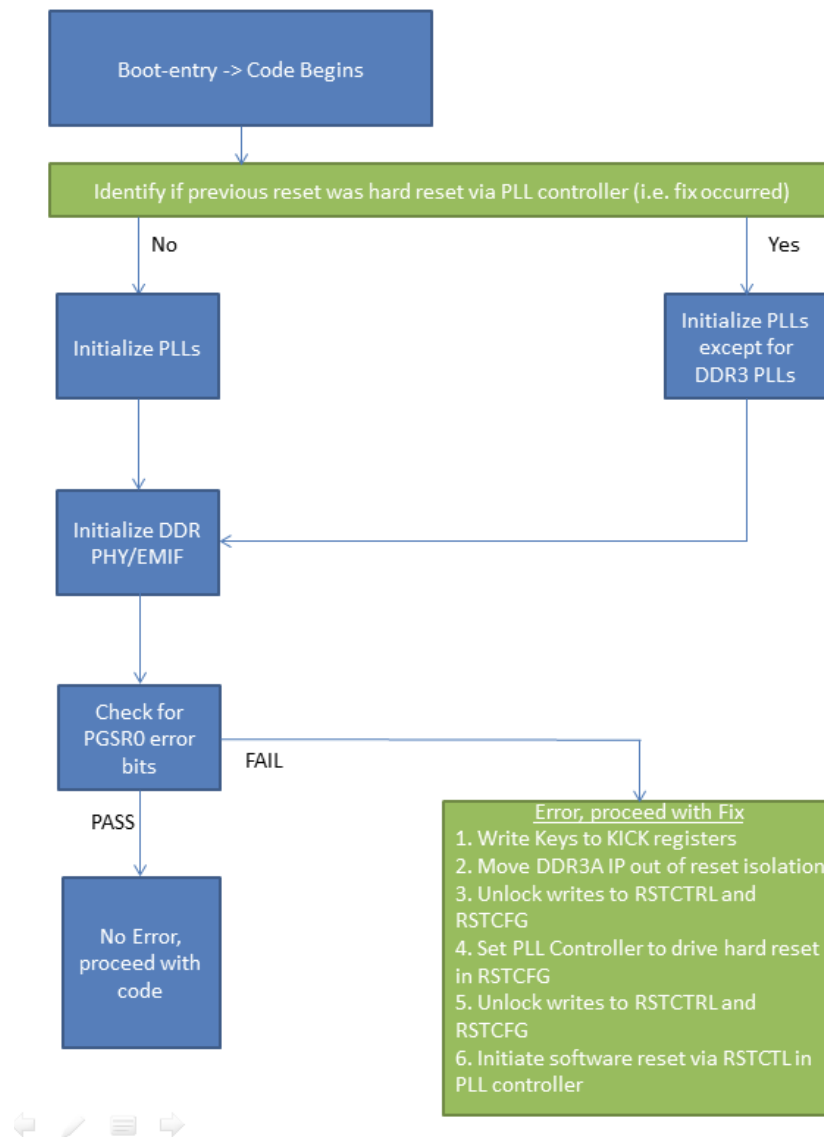
**Figure 3. Software Reset Using the RSTCTRL Register**

The root cause is identified to an issue that happens after the very first DDR3 PHY initialization, this first initialization happens directly from Power-on reset. The issue occurs because the clocking requirements of the DDR3 PHY are not met on the first initialization, this happens because the DDR3A and DDR3B SoC PLLs are not yet programmed to provide the requisite clock. There is a ratio requirement between the DDR3A/B PHY clocks and the core configuration clock, such that the core configuration clock must be less than or equal to the PHY clock. These clocks are asynchronous and the PHY support an asynchronous FIFO scheme with limited depth on the PHY clock domain. If the ratio requirement is not met then FIFO can overflow. This would mean that the configuration data for the PHY may be lost during the initialization sequence. Experiments have proven that if we apply Hard Reset once the clocking has been set up correctly, the issue is resolved.

DDR read/write failures can be avoided by checking the DDR PHY status register for any Leveling errors at the end of DDR PHY Initialization. For boot modes using DDR, the workarounds below can be used as a part of second-stage boot only. Once the leveling errors are detected, one of the following workarounds can be used.

BLUE colored blocks show the normal execution while the GREEN colored blocks show the changes. The “Error, proceed with Fix” block is the block which explains the steps that need to be followed to apply the Software Reset using RSTCTRL register. The steps are mentioned for DDR3A. The same steps need to be used for DDR3B also.

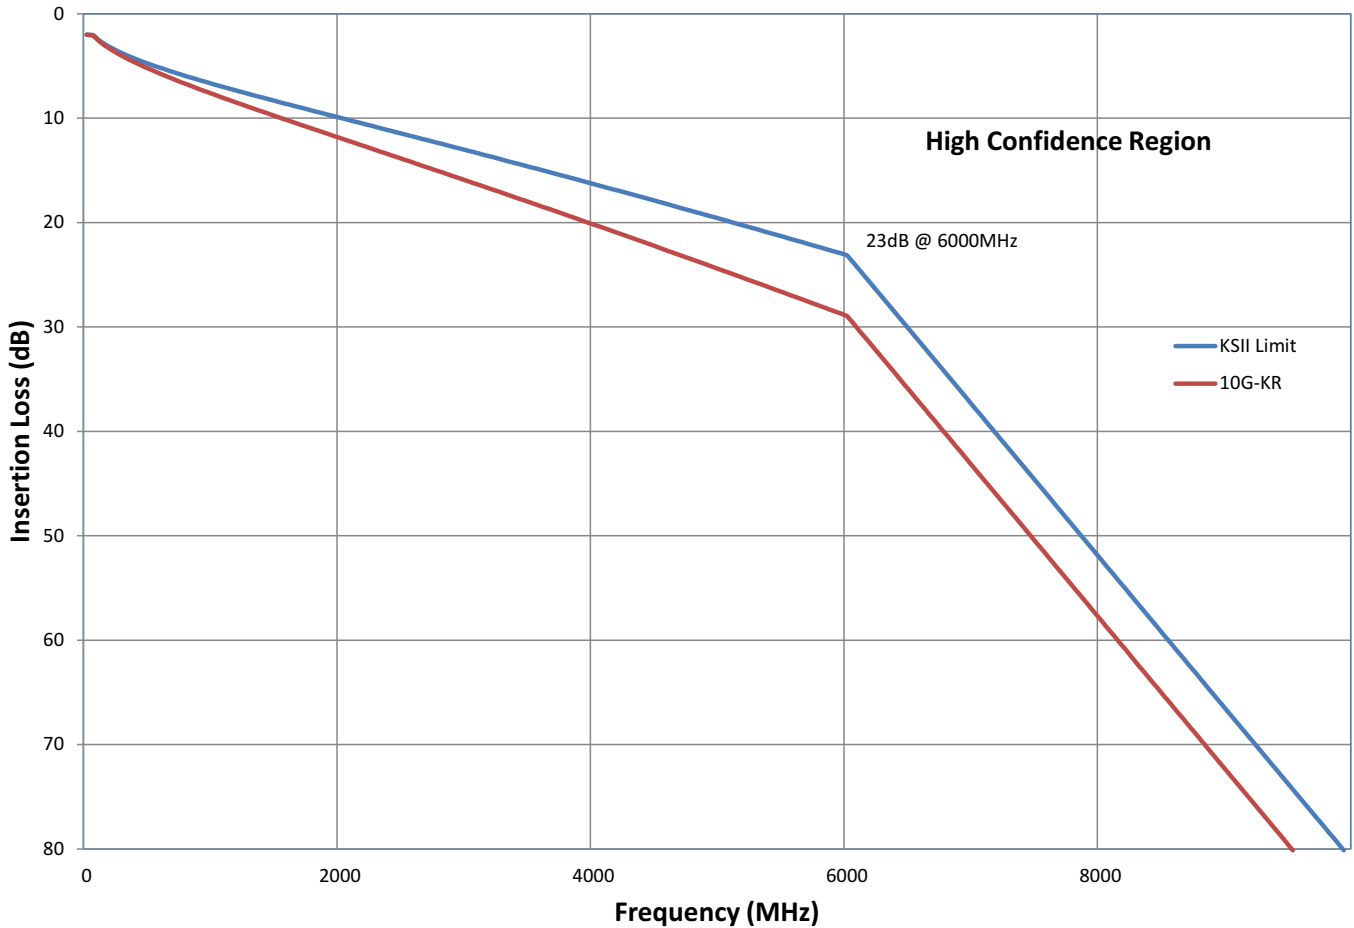
Device characterization has shown that bit error rate performance consistent with the 10GbE-KR standard as published in IEEE 802.3-2008 Annex 69B cannot be met across all device operating extremes. Production devices do operate at the required error rate across all rated operating conditions of voltage and temperature when the channel insertion loss is limited to 20dB at the Nyquist rate of 5.15625GHz. The figure below shows the Insertion Loss template from IEEE 802.3-2008 Annex 69B as well as the reduced Insertion Loss template.

Characterization has shown that channels must also be compliant with the Return Loss template contained in the IEEE 802.3-2008 Annex 69B specification without modification. This is shown below for convenience.

**Workaround**      None.

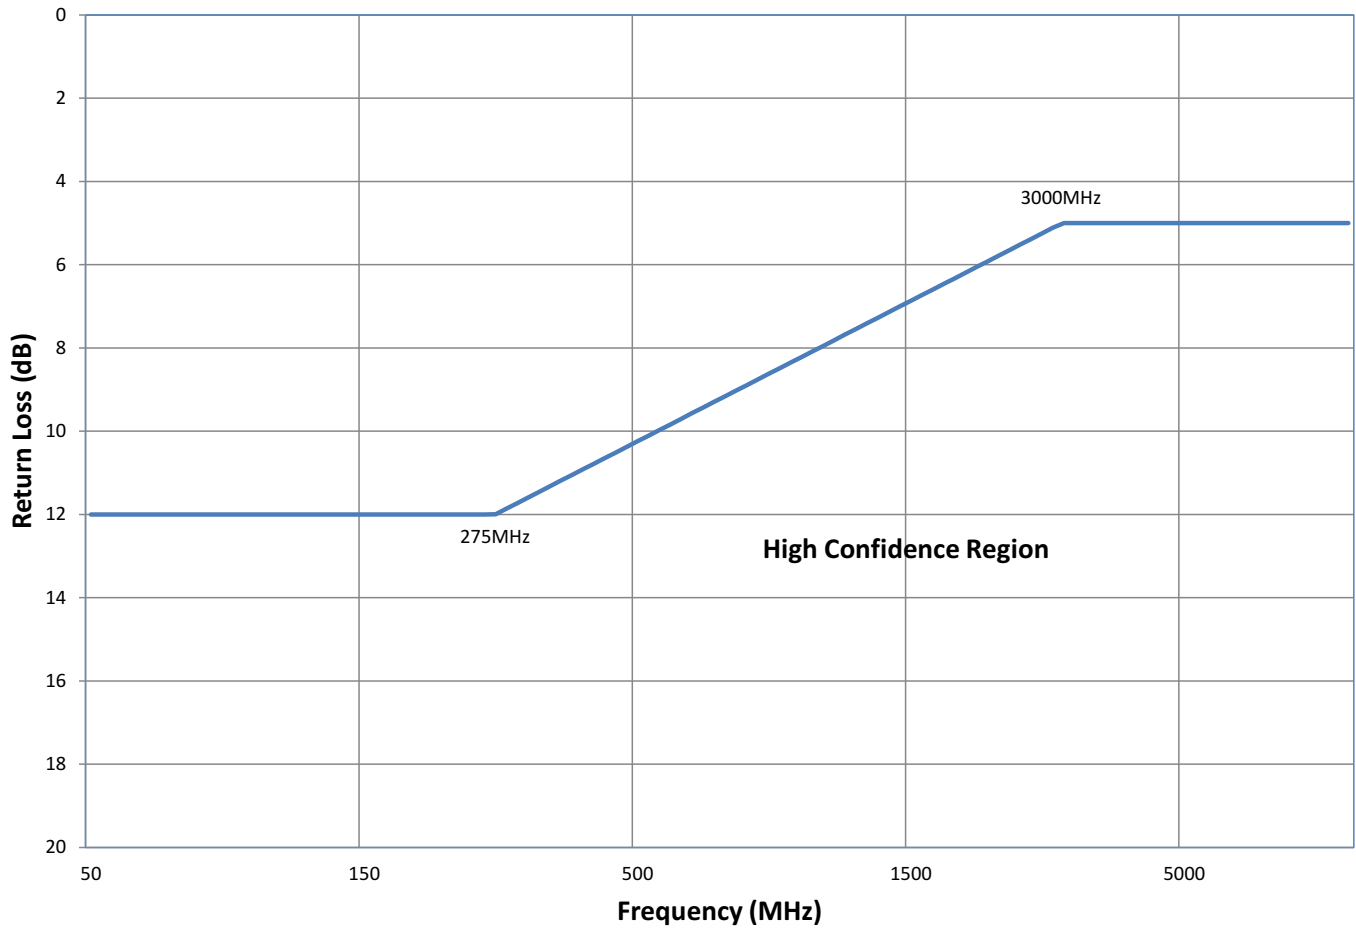
Device characterization has shown that expected bit error rate performance can only be met on layouts that meet constrained channel loss metrics. These can be examined by generating Insertion Loss and Return Loss graphs where loss is plotted versus frequency. Insertion Loss and Return Loss can be estimated during PCB layout using a 3D simulation tool. Insertion Loss and Return Loss should also be measured on early prototypes using a Vector Network Analyzer (VNA). Multiple PCB construction and layout enhancement techniques must be combined to achieve these channel performance requirements as stated in the KeyStone II SERDES User Guide.

An Insertion Loss measurement provides a composite view of the channel's loss versus frequency. Since HyperLink is a short-reach interface, channel loss is limited. Also, due to the high data rate, the Insertion Loss must be monotonic and without discontinuities that would degrade receiver operation. The template shown below provides Insertion Loss limits that will result in a robust channel. This template must be met for the entire channel from transmitter to receiver including the series capacitors.

Device characterization has also shown that channels should be compliant with the Return Loss template shown below. The Return Loss measurement indicates the amount of energy reflected back to the source which is not available to the receiver. Impedance variation in the channel will cause reflected energy that can cause this template to be violated. Careful attention to PCB construction and layout must be followed to meet this requirement. This template must be met for the entire channel from transmitter to receiver including the series capacitors. Note that this is the same template

**Workaround**      None.

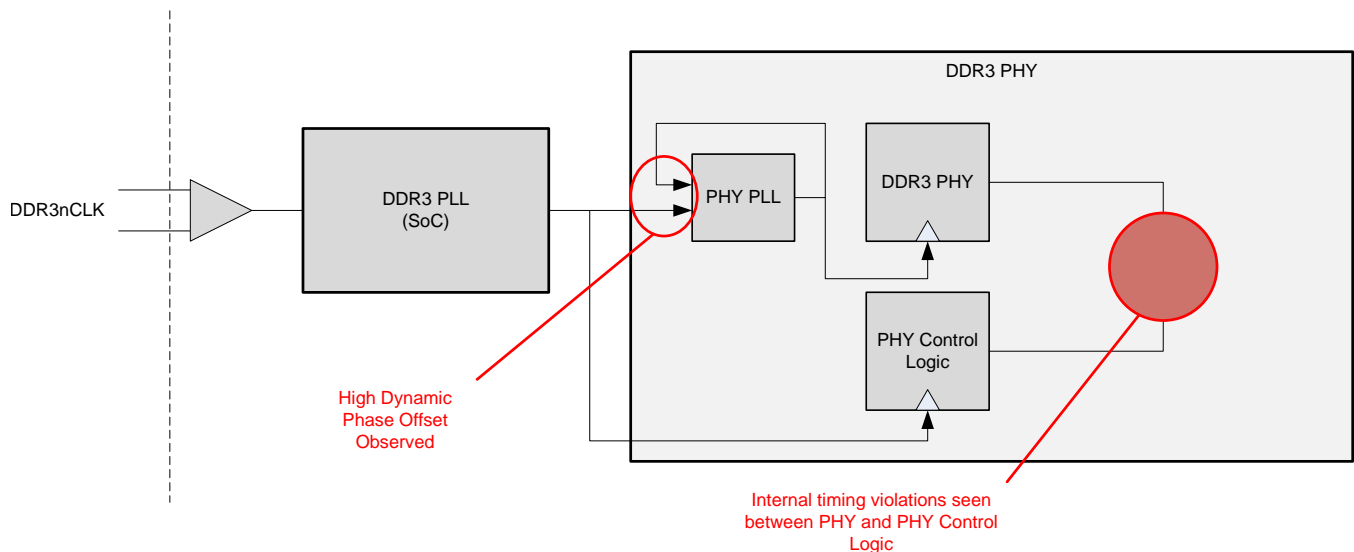
**Figure 5. DDR3 PHY**

DDR3 read operations may show errors due to increased levels of Dynamic Phase Offset (DPO) inside the DDR3 PHY. These errors are characterized by byte lane data corruption or intermittent bit errors. The byte lane data corruption can only be recovered using a device reset.

The DDR3 clocking architecture is illustrated in the figure below. The DDR3 reference clock input (DDR3nCLK) feeds the DDR3 SoC PLL, which outputs a clock to be used by the PHY Control Logic and provide an input to the PHY PLL.

The Dynamic Phase Offset (DPO) is a measure of the DDR3 PHY PLL’s ability to track rapid phase changes in the output of the DDR3 SoC PLL. High DPO can create internal timing violations between the DDR3 PHY and DDR3 PHY Control Logic and result in data errors during reads. As indicated by the shaded red circle in the figure above, the timing violations occur in the data transfer between the PHY and PHY control logic. It was determined that the root cause of the elevated DPO were SoC PLL and PHY PLL configurations that were non-optimized for the timing requirements of the system.

The workaround for this behavior is a change in the PLL configurations used for the DDR3 SoC PLL and the DDR3 PHY PLL. New configurations have been generated for DDR3-1600, DDR3-1333, DDR3-1066, and DDR3-800 operation and are presented in the tables below. Per field alert, "DDR3 Limited to Highest Data Rates Due to Possibility of PLL Instability During Temperature Changes after Startup", operation of DDR3-1066 and/or DDR3-800 is not recommended for affected Keystone2 devices in production systems

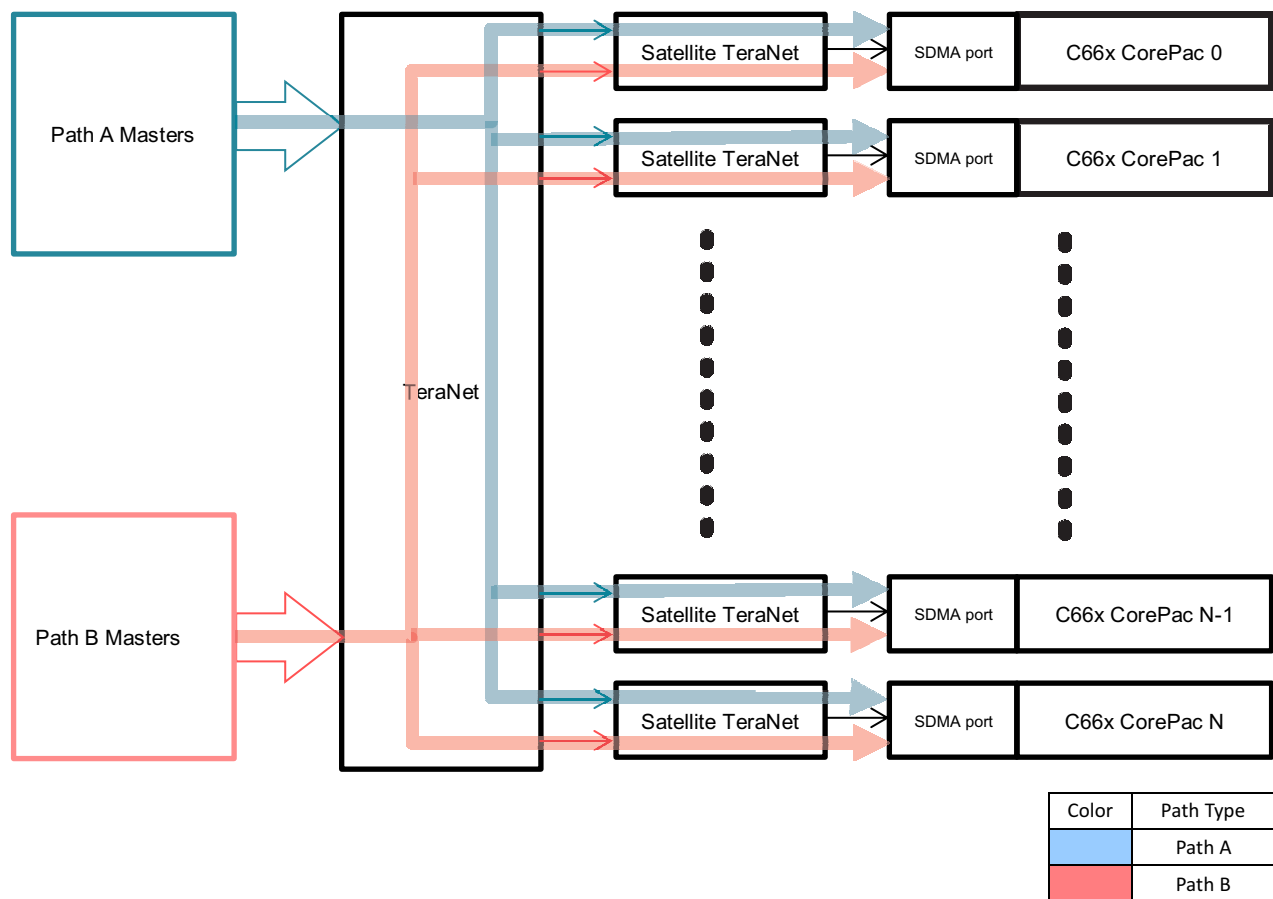
**Figure 6. Satellite TeraNet Paths**

When two masters send out write transactions to two C66x CorePac's L2 slave end points, a hang can occur when the C66x CorePacs are busy and stalling the incoming write transactions.

Each C66x CorePac has a TeraNet component in front of its slave (SDMA) port, which serves as a satellite TeraNet for C66x CorePac's SDMA port. Device masters communicate with the C66x CorePac's L2 memory through these satellite TeraNets. These satellite TeraNets have two input paths, path A and path B, and each path can be accessed by distinct set of masters. Thus, each write transaction appearing at the SDMA ports of C66x Corepac L2 memory can take one of the two possible paths, depending on the master that sent out that transaction.
