These errata apply **ONLY** to Spartan-3 XC3S200 FPGAs, including both production devices and engineering samples. These errata **DO NOT** apply to any other Spartan-3 FPGA. If using a different Spartan-3 FPGA, check for errata specific to that device.

Thank you for your interest in Spartan-3 XC3S200 FPGA devices. Although Xilinx has made every effort to ensure that these devices are of the highest possible quality, these devices are subject to the limitations described in the following errata. Please review these errata to ensure that XC3S200 FPGA devices meet your application requirements. Xilinx wants you to know about any known issues that may potentially affect your Spartan-3 application. This notice also includes [advisories](#) on the latest Spartan-3 design practices.

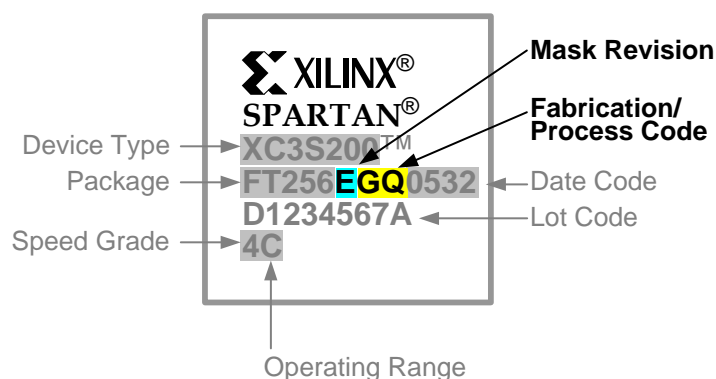
Figure 2: Spartan-3 FPGA from UMC 300 mm facility with “GQ” Fabrication/Process Code Marking

This issue only applies to those designs using the Readback feature on the XC3S200 FPGAs shown in [Table 8](#) with a "CGQ" Fabrication/Process Code marking, as shown in [Figure 2](#).

The readback feature is not available for the devices indicated in [Table 8](#).

This issue is corrected on XC3S200 FPGAs with a “BGQ” mask/fabrication/process code marking, as shown in [Figure 2](#).

This issue is corrected on XC3S200 FPGAs with a “BGQ” fabrication/process code marking, as shown in [Figure 2](#).

This issue is corrected on XC3S200 FPGAs with a "BGQ" fabrication/process code marking, as shown in [Figure 2](#).
